## REPORT

Of the Post-seismic Mission on the Mexico earthquake  
of September 19th, 2017

February 2018

Association Française du Génie Parasismique  
French Association for Earthquake Engineering

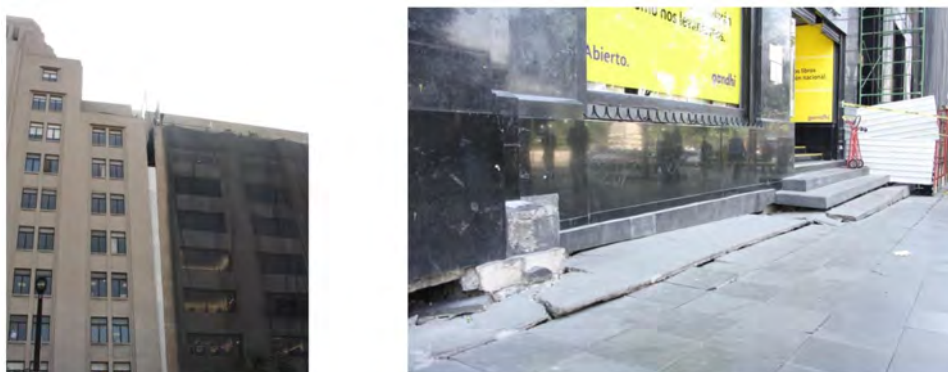
*Figure 5.4 – Avenida Juárez (Delegación Cuauhtémoc, Mexico)*

5.4). In these cases, which involved buildings at least six stories in height, structural pathologies were also visible. We selected a number of examples which are described below.

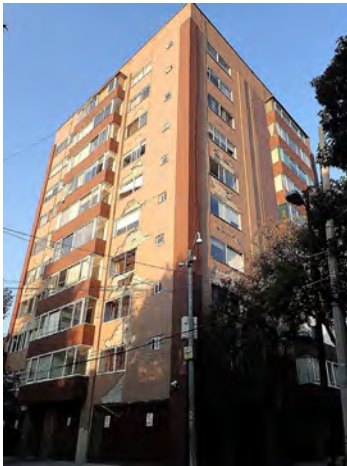
Figure 6 13 – General view of a damaged building

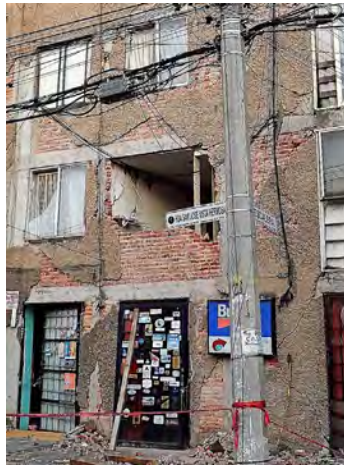
- The first involves the out-of-plane displacement, and subsequent fall, of all or parts of the infill bricks making up the masonry walls (Figure 6-14). This type of damage occurred following movements perpendicular to the walls and/or a torsion of the building. This mechanism was observed in walls with or without concrete stiffeners.
- The second involves the presence of 45° diagonal cracks, typical of shear failure of the infill panels (in-plane failure) (Figure 6-15). This demonstrates that the braces failed to deal with the stresses involved.

Figure 6 14 - Out-of-plane failure of masonry infill

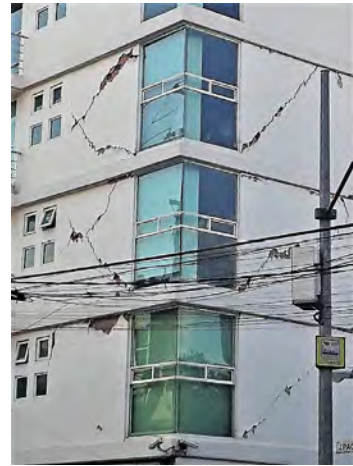
Figure 6 15 - Shear failure of the infill masonry

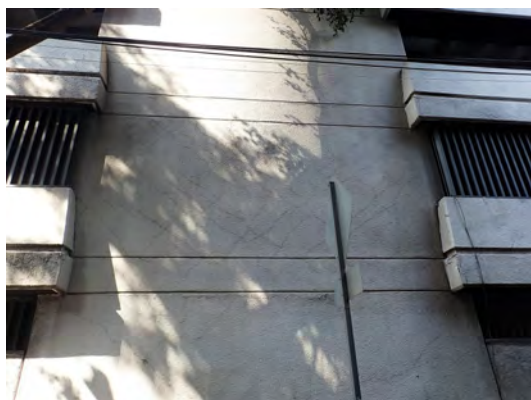
Figure 6 18 - Shear cracking of a panel

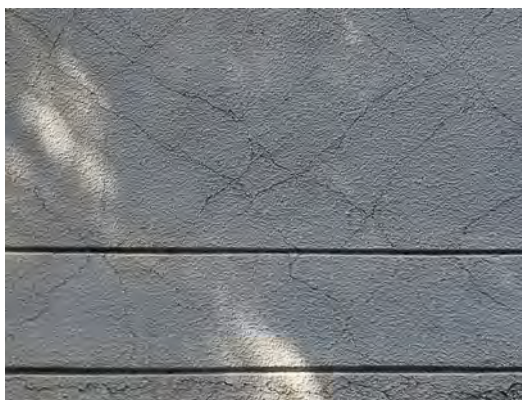
Figure 6 19 - Appearance of the shear crack (detail)

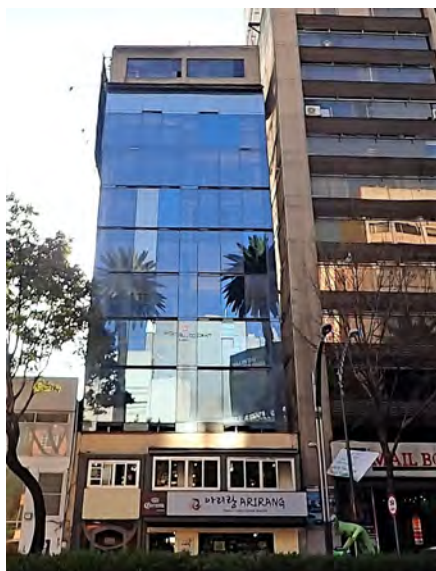
Figure 6 21 - Tilting (left) of a building

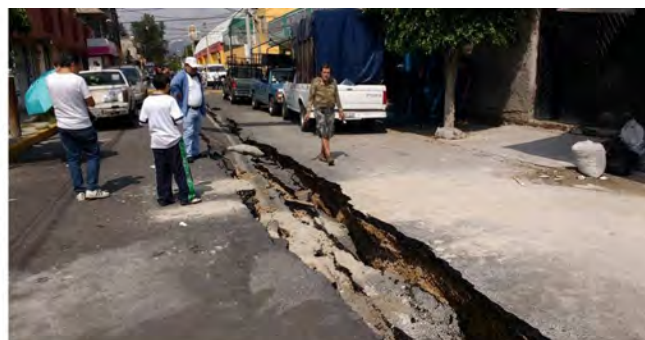
Figure 8.2 – (Pipe repair works in Ixtaltepec (Oaxaca). (Right) Road collapse in Tlahuac (CDMX) due to a damaged water pipe.

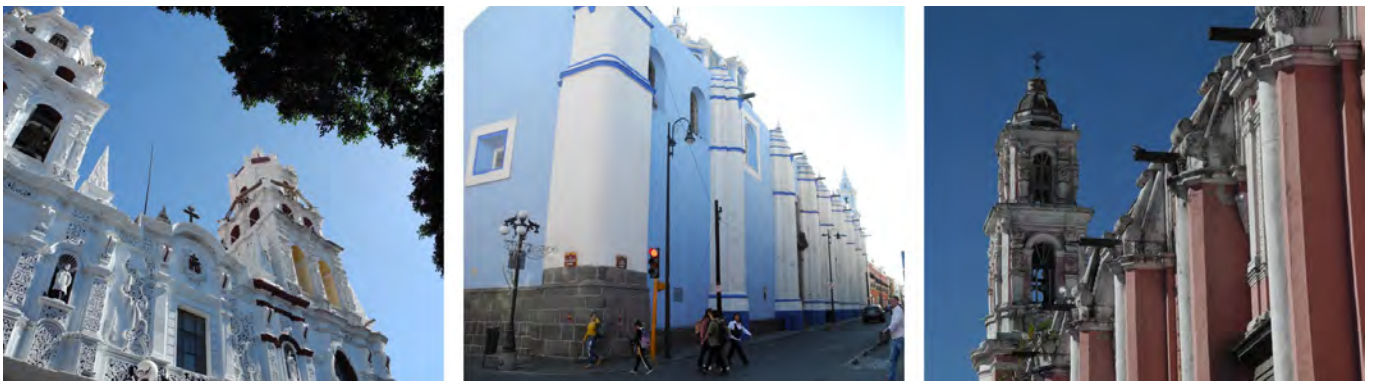
Figure 15.4 – Puebla, view of a number of churches exhibiting minor damage

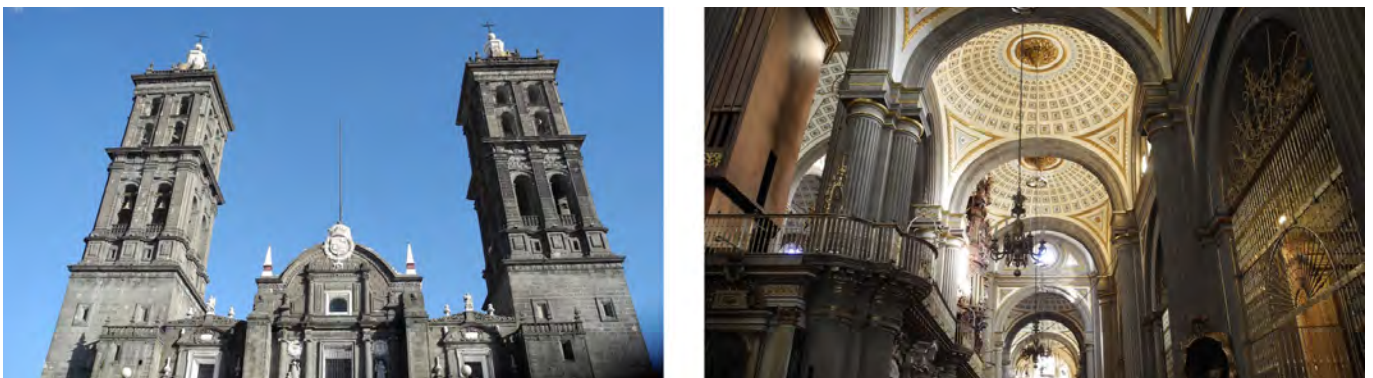
Figure 15.5 –Puebla Cathedral, strengthened following the 1999 earthquake, is in perfect condition

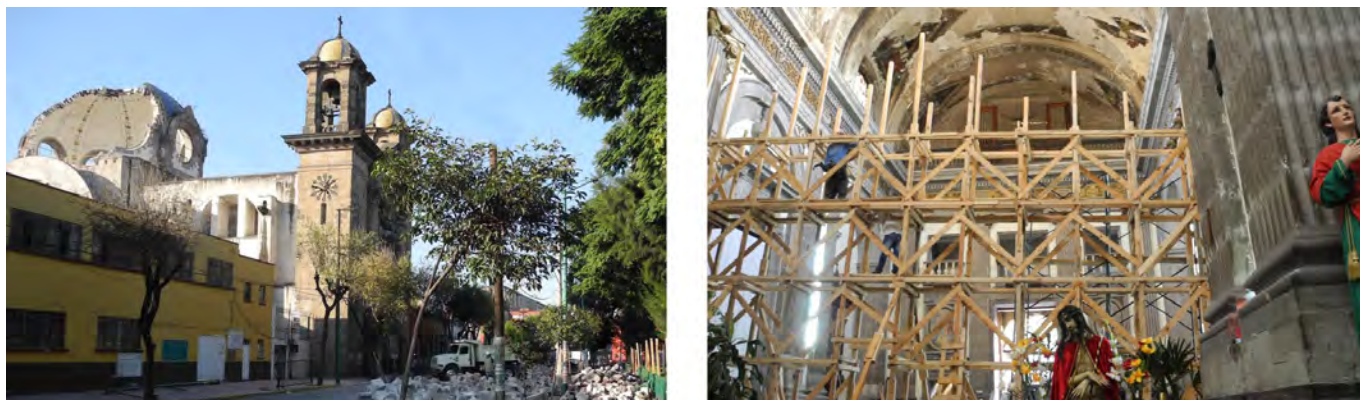
Figure 15.6 – Mexico City: Collapsed dome of Nuestra Senora de los Angeles, ongoing shoring work in Nuestra Senora de Loretto

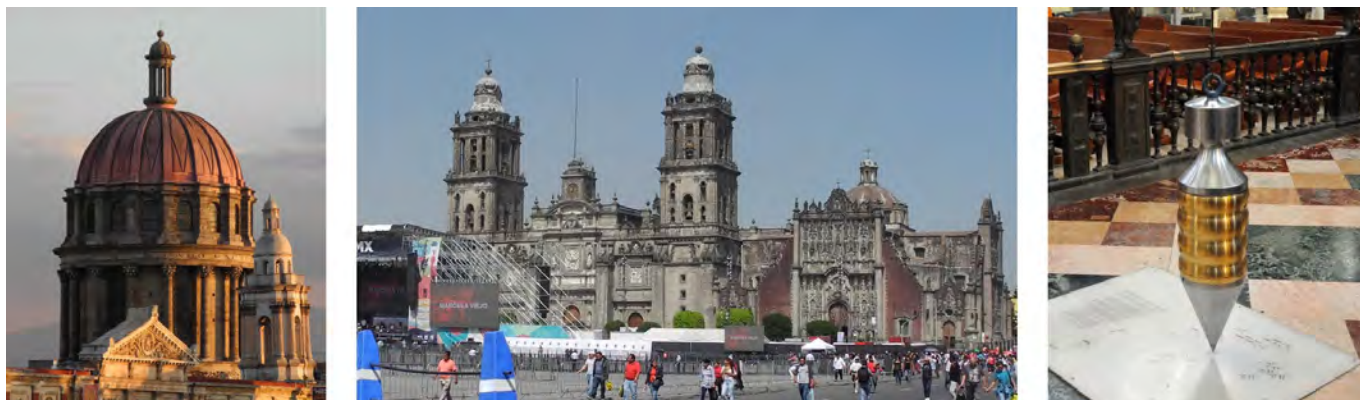
Figure 15.7 – Mexico City: various examples of tilting, the Cathedral and its pendulum
