## REPORT

Of the Post-seismic Mission on the Mexico earthquake  
of September 19th, 2017

February 2018

Association Française du Génie Parasismique  
French Association for Earthquake Engineering

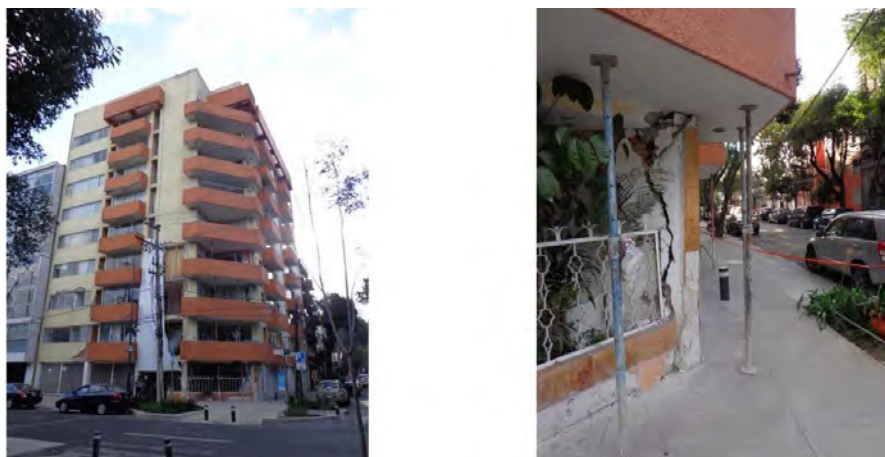
For buildings whose structure is visibly damaged, we also note that, even when the superstructure shows signs of strong earthquake-response movements, deformations at the soil-structure interface are not always obvious and are sometimes non-identifiable.

This is the case for two selected examples: a corner building located on Calle Morelia in the Colonia Roma (Figure 5.5) and building number 872 located on the Avenida Cuauhtémoc (Figure 5.6). The latter is situated close to an area where structures were destroyed by the earthquake at the junction between the Calle Concepción Beistegui and the Calle Yacatas.

*Figure 5.5 – Calle Morelia  
(Delegación Cuauhtémoc, Mexico)*

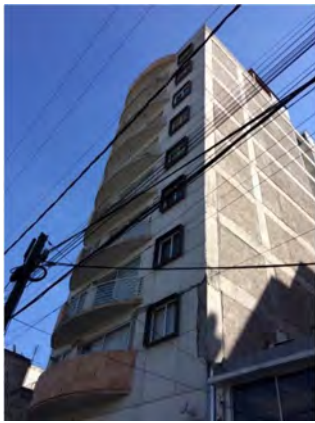
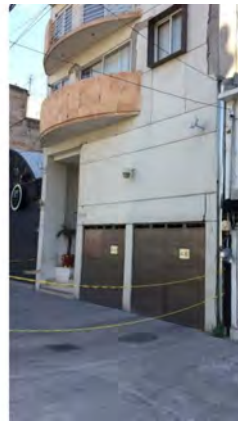
Figure 5.6 – Avenida Cuauhtémoc  
(Delegación Cuauhtémoc, Mexico)

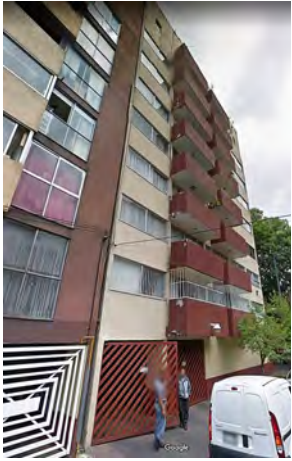
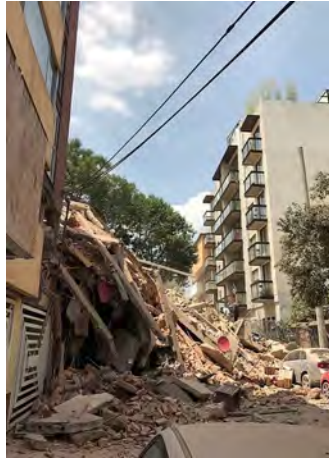
- **Their location coincided with the “geological transition zone”,** corresponding to more homogeneous lacustrine and colluvial deposits on the edge of zones IIIa and IIIb (Figure 6-7) ;
- **Their construction type was reinforced concrete frame with masonry infill.** (Figure 6-9, 6-10, 6-11);
- **They were between 4 and 8 floors in height.** Figure 6-8 displays the distribution of collapsed buildings as a function of the number of floors for 32 buildings;
- **Their construction predates the 1990s.** It is worth noting that only one recent building (less than five years old) collapsed.

Figure 6 9 - 9 floors

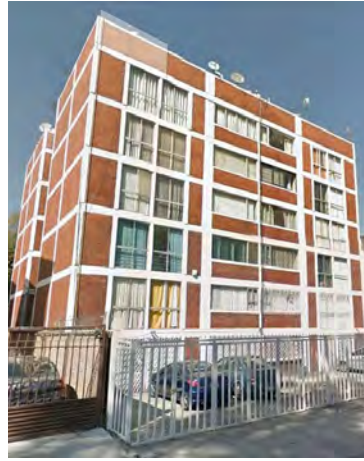
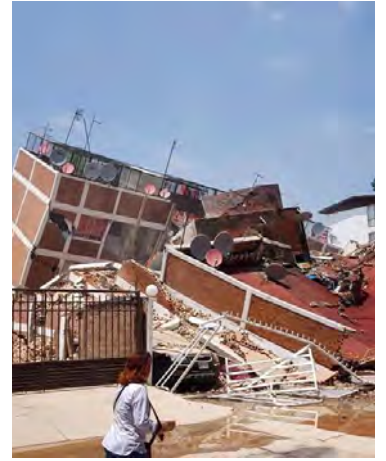
Figure 6 10 - 6 floors

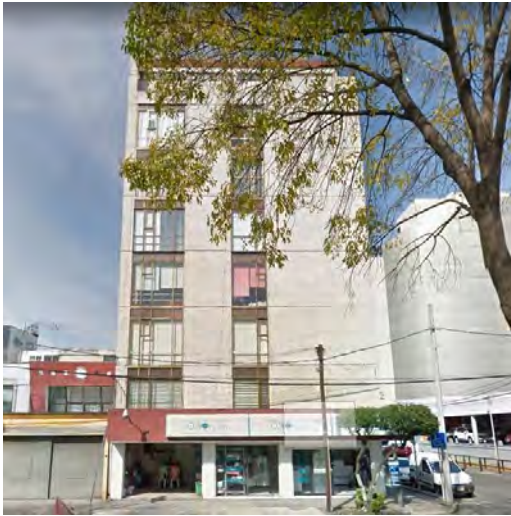
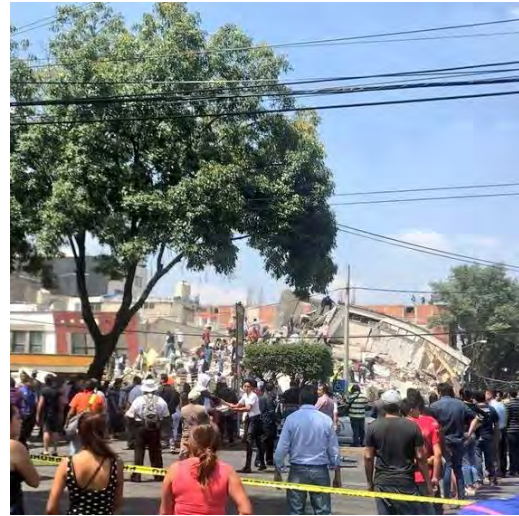
Figure 6 11 - 8 floors

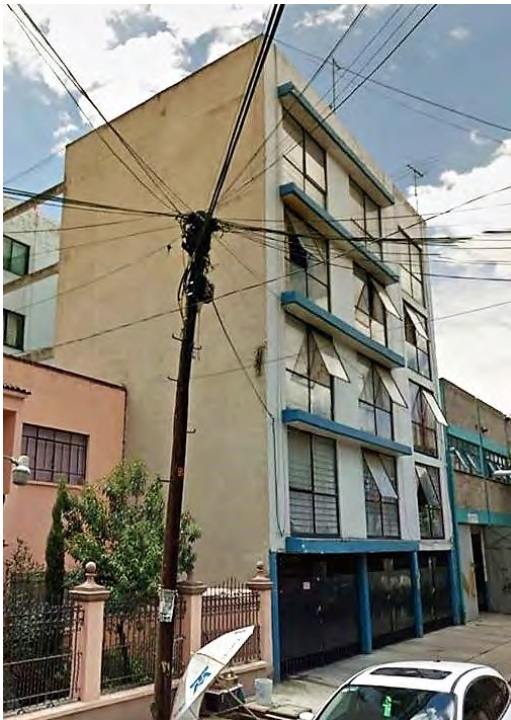
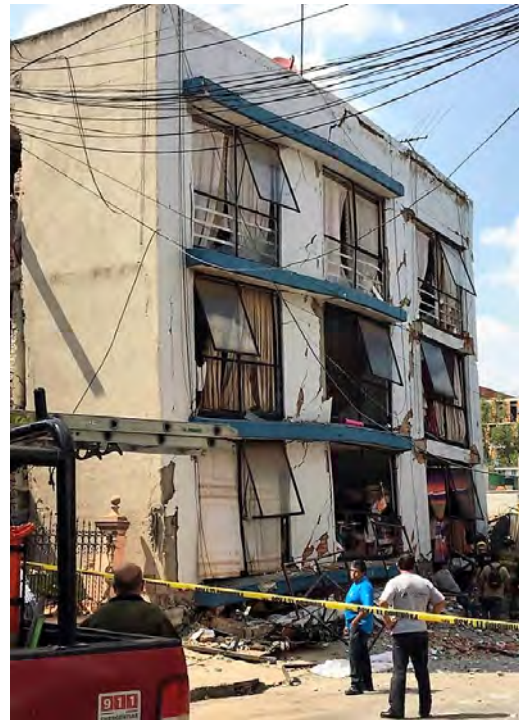
In partially collapsed buildings, it appears that destruction may have been caused by the failure of a single floor (including the ground floor) (Figure 6-12). It seems, therefore, that the relative rigidities of the floors played a significant role, be they linked to the building's original design or to localized loss of rigidity arising from its dynamic response (e.g. loss of masonry infill).

Figure 6 12 - 5 floors

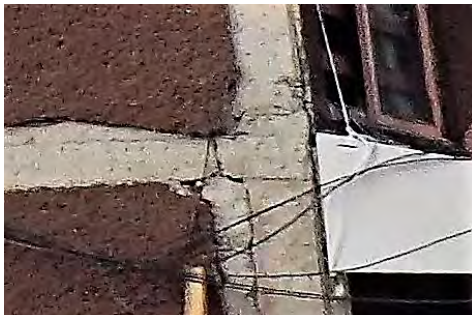
- For some of these constructions, significant damage was observed at the post-beam junctions (Figure 6-16), in particular on the first and second floors.
- On rare instances, beam failure was observed (Figure 6-17). These failures are counter intuitive as they present the appearance of shear strength failure (45° cracks) even though they occur at half-span, where flexural strength failure (vertical cracks) would be expected. It is likely that, in these cases, the masonry infill and its deterioration led to the transfer of some parasitic stress to the beam.

Figure 6 16 - Post-beam junction failure

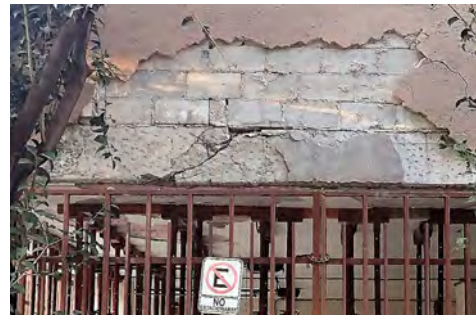
Figure 6 17 - Shear failure of a beam

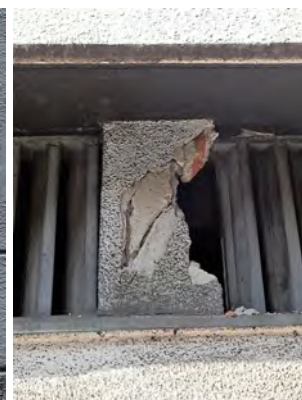
Figure 6 20 - Short post failure

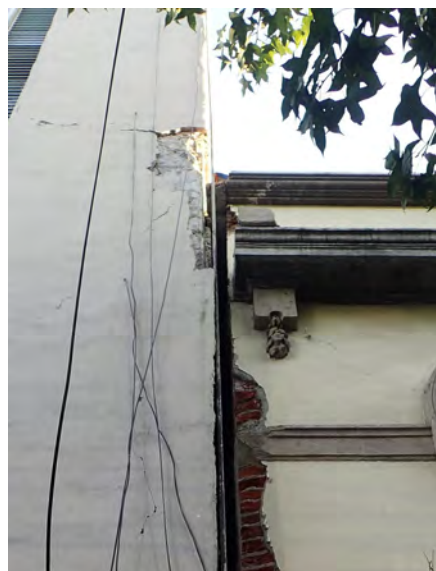
Figure 6 22 - Collision between buildings of different typologies

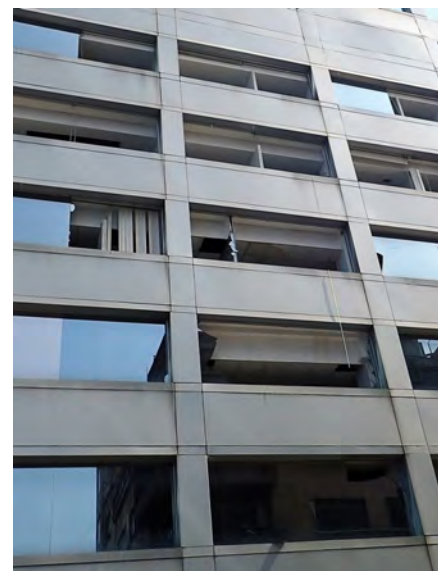
Figure 6 23 - Loss of non-structural glass panels

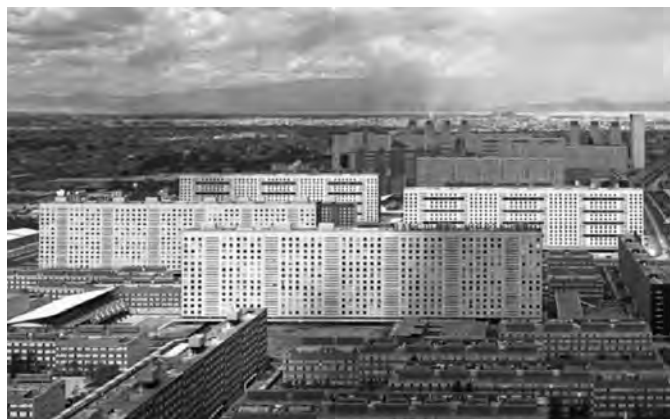
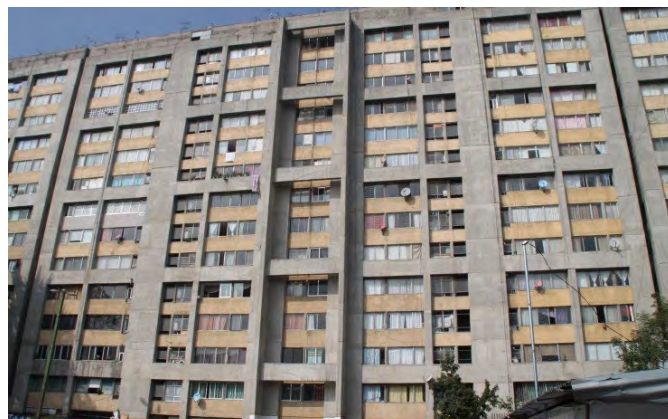
Built between 1960 and 1964, the «Nonoalco Tlatelolco» residential complex symbolic of the concentration of population in Mexico City. During the 1985 earthquake, this district witnessed significant cases of building collapse and a campaign of strengthening works on the reinforced concrete buildings ensued. Figures 7-5 and 7-6 show one building in the complex before and after strengthening.

During the September 19th 2017 earthquake, the building did not incur any visible structural damage, even though it had been subjected to horizontal displacements of approximately 50 cm.

- Implanting new piles 6.5 m from the façade,
- Dividing the whole structure into substructures by removing some of the gable panels over the full height, so as to shorten the initial structure by 35 cm and to create a 70 cm space between each of the new modules,
- Installing stiffeners over the full height of both principal façades,
- Inserting beams to link the posts on every third floor.

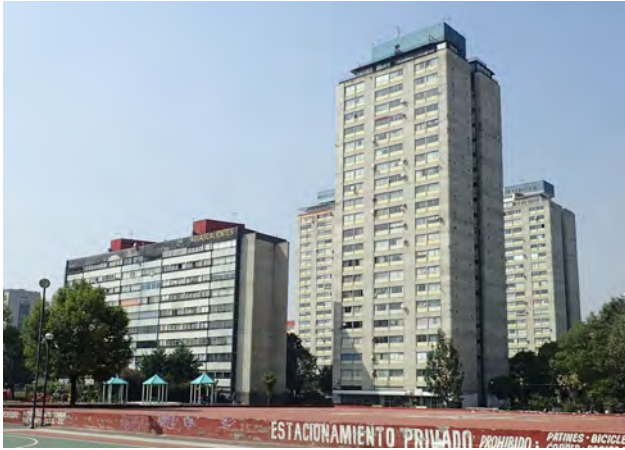
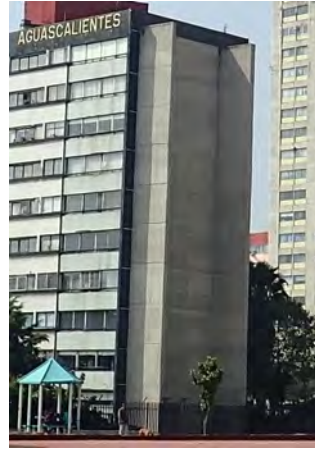
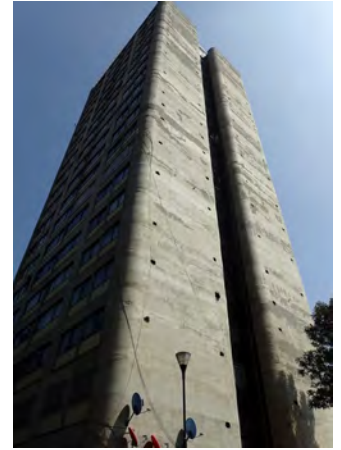
In this case we are looking at the strengthening of four buildings built in 1964 and belonging to the same urban complex as the previous example. The buildings, of a type commonly referred to as “tower blocks”, were strengthened by attaching concrete panels to their façades. Figures 7-8 to 7-10 show the two types of strengthening works carried out. It should be noted that these buildings behaved quite well during the September 19th 2017 earthquake.

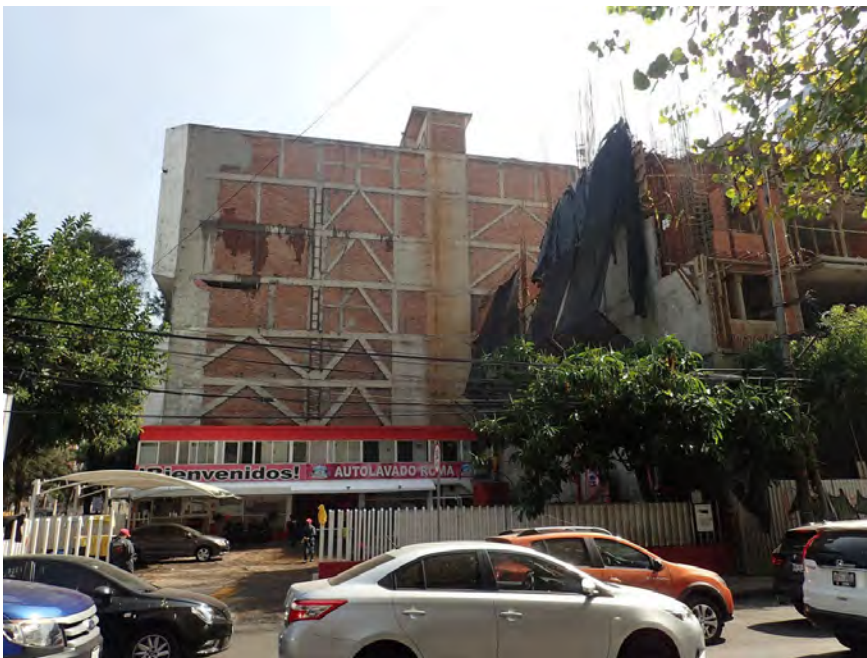
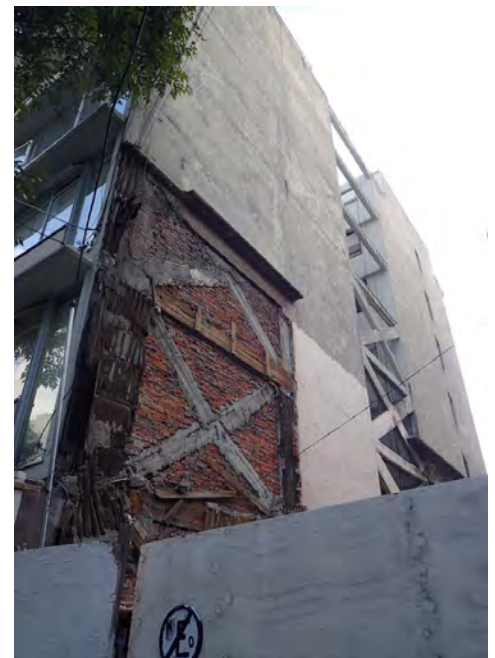
The presence of cross- and V-shaped braces was regularly observed on the façades of buildings constructed using a reinforced concrete post and beam frame with masonry infill (Figure 7-11 and Figure 7-12). It is not always easy to decide whether these braces were installed during the initial construction stage or at a later date.

This type of bracing is also used to consolidate two parts of a single building presenting a potential risk of torsion (Figure 7-12). The buildings fitted with this type of bracing did not exhibit any visible damage, apart from the occasional missing brick.

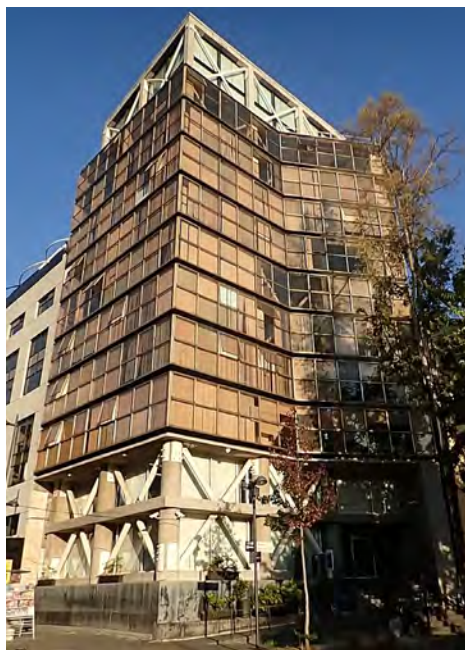
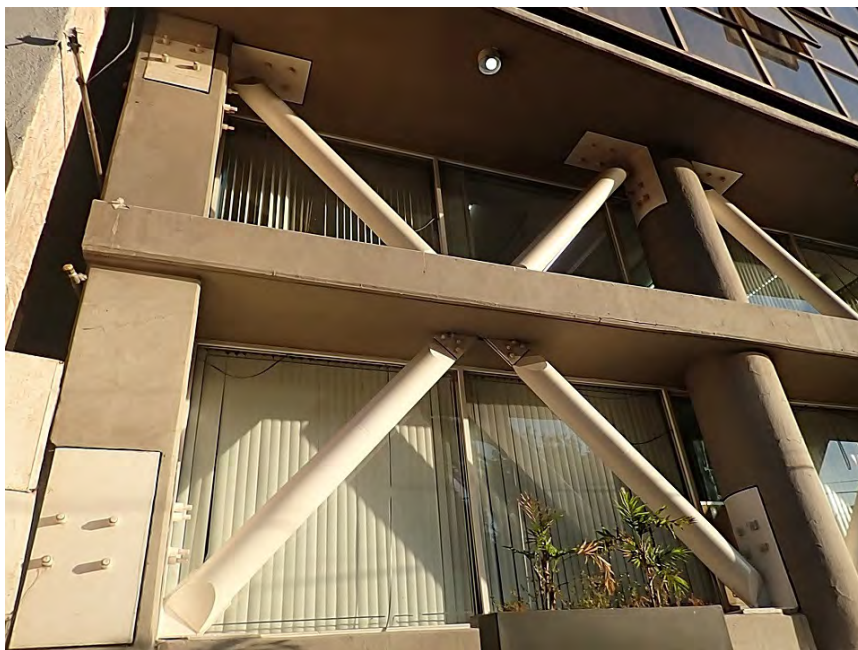
Figure 7-13 shows a 10 story concrete building located in the Roma district (one of the worst affected areas). It has been strengthened in its entirety using cross bracing mounted on the exterior and also on the interior of the building. This building did not display any visible damage following the September 19th 2017 earthquake.

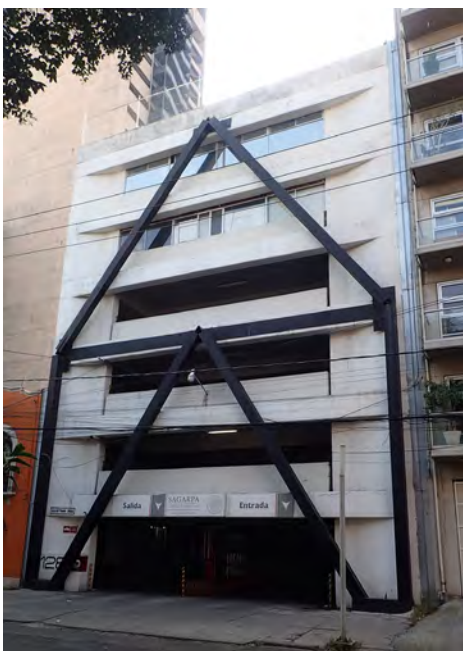
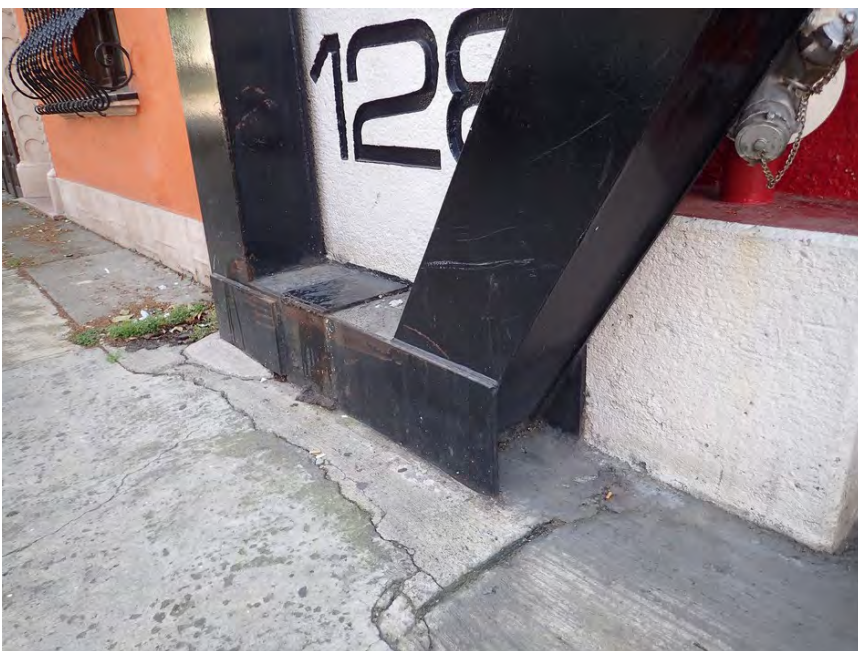
Figure 7-15 and Figure 7-16 show retro-fitting using metal profiles on the façade of the 6 story Ministry of Agriculture building. Apart from increasing the capacity of the building, this type of strengthening also helps to restrict lateral displacements and, consequently, reduces the risk of collision. This building did not display any visible damage following the September 19th 2017 earthquake.

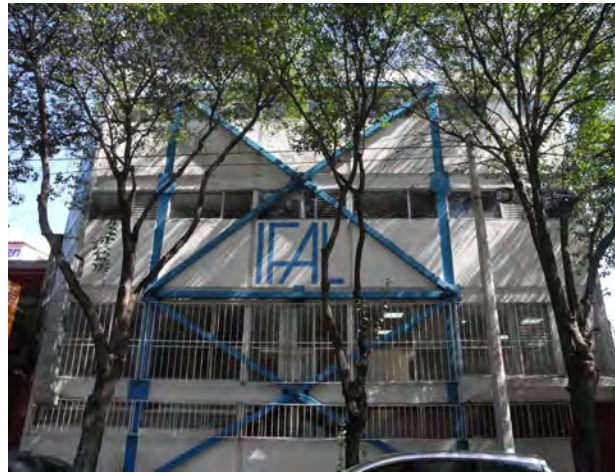
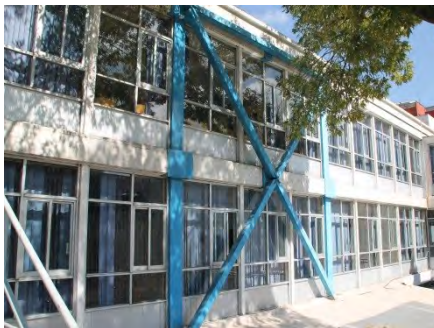
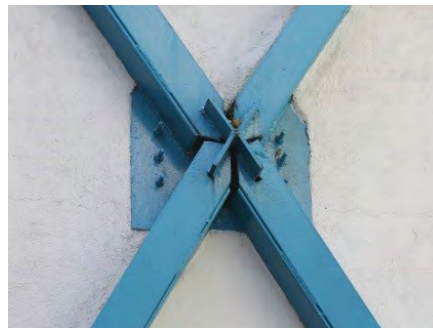
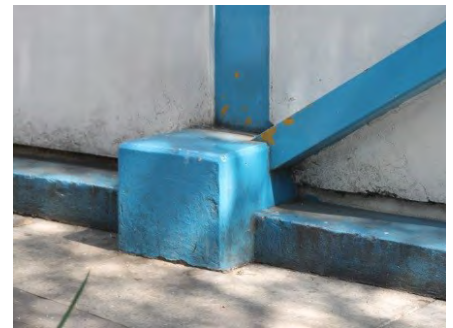
Figures 7-17 to 7-19 show the retro-fitting works carried out in 1990 at the French Institute of Latin America (IFAL), which comprises several two- and three story buildings.

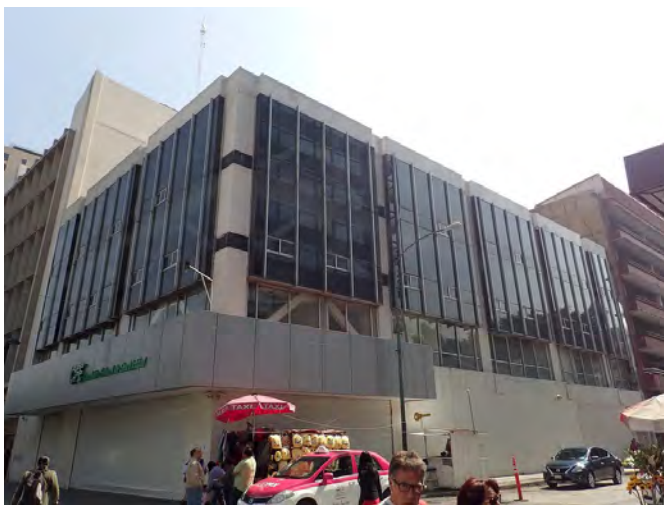
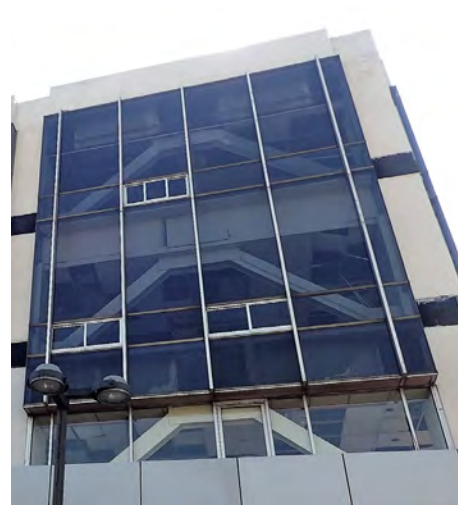
Figures 7-20 and 7-21 show a three story building to which a strengthening system has been fitted to the corner. This layout was certainly adopted in order limit the problem of torsion. Through the windows we can get a glimpse of the suspended ceiling is missing many suspended ceiling panels, indicating that the building was subjected to substantial tremors during the September 19th 2017 earthquake. However, it does not display any visible structural damage.

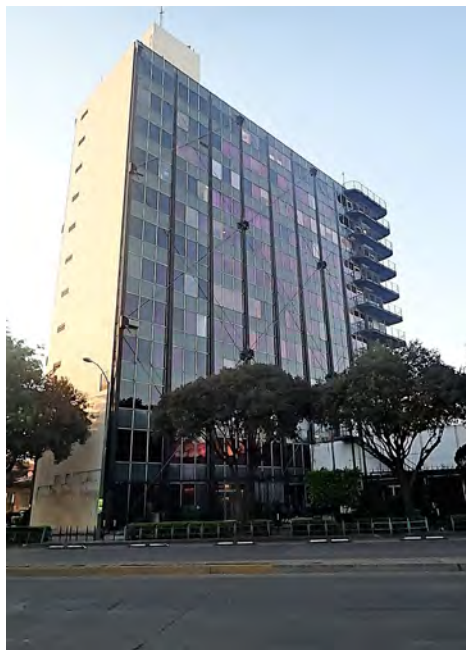
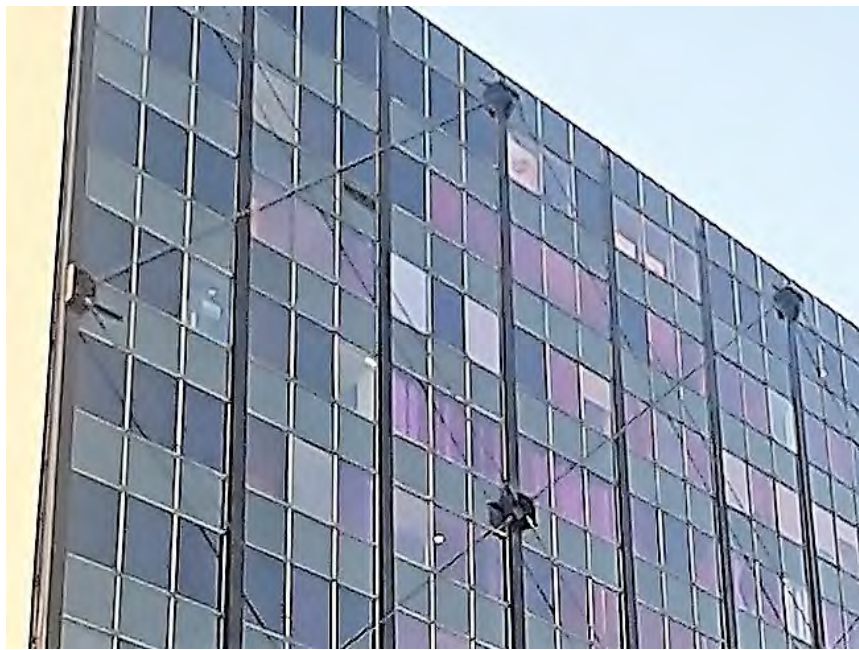
Figures 7-22 and 7-23 show the retro-fitting works to a building whose bracing system consists of metal tie rods anchored to every fourth floor. This building did not exhibit any visible damage.

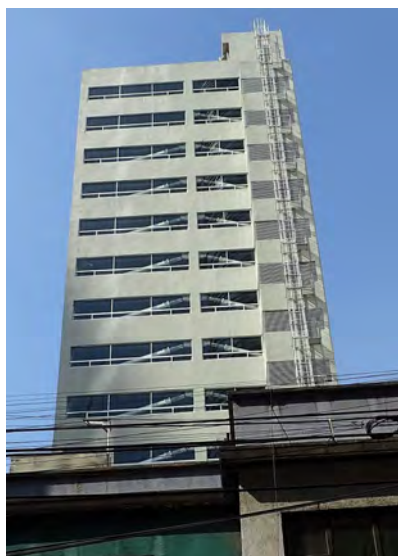
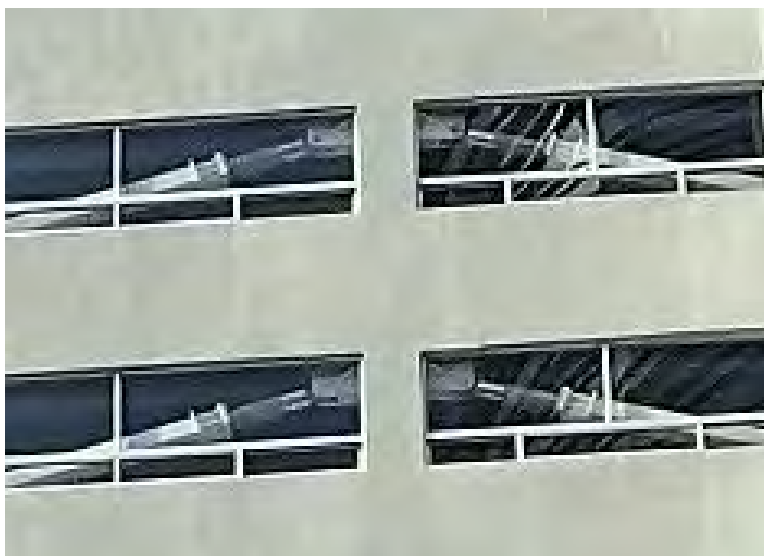
This type of retro-fitting is the subject of a recent standard introduced in December 2017. Therefore, the examples presented here did not fall under any Mexican standard at the time of their installation. The first buildings strengthened using the energy dissipation technique are over 25 years old. No visible damage was noted on the buildings we examined that were strengthened in this manner.

Figures 7-24 and 7-25 show a diagonal, viscoelastic-type strengthening system.

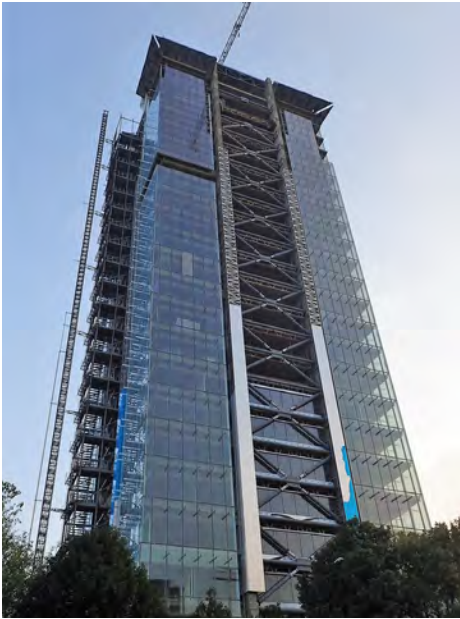
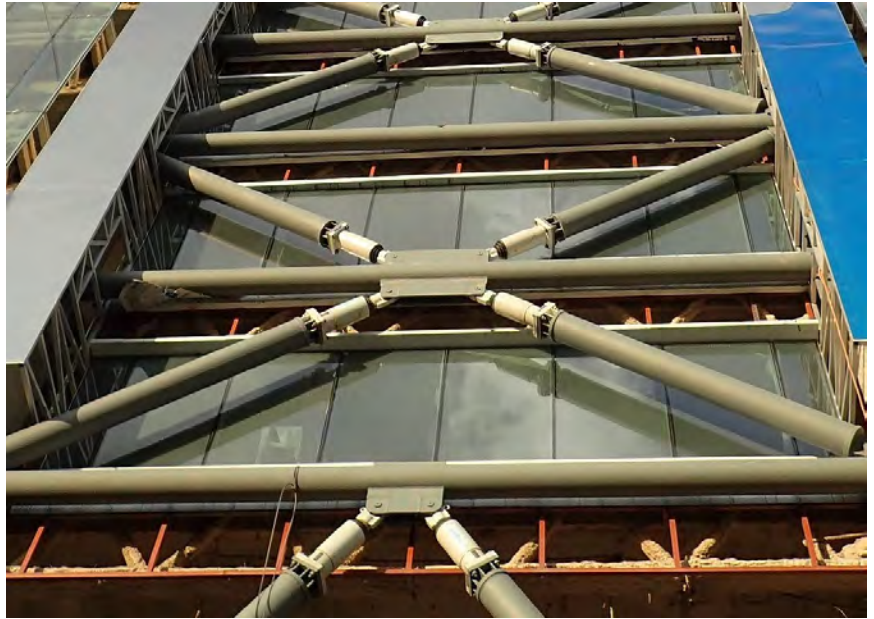
Figure 7-23 and Figure 7-24 show the ongoing strengthening works on the building of the Ministry of the Economy, initiated nearly two years ago. A combination of horizontal stiffeners and diagonal dissipaters has been fitted over the full height of the building. These retrofitted elements are applied to the original reinforced concrete structure. No visible damage was observed on this building.

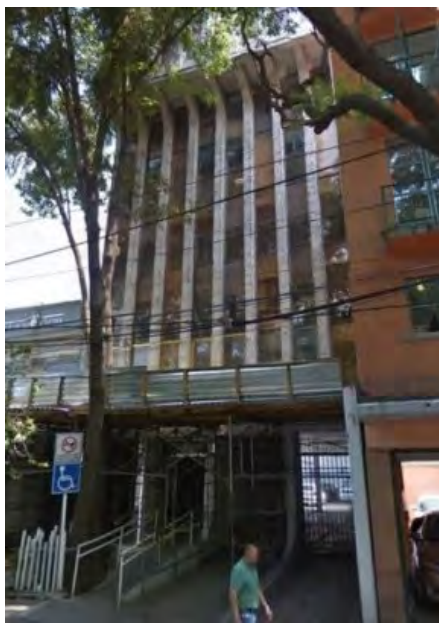
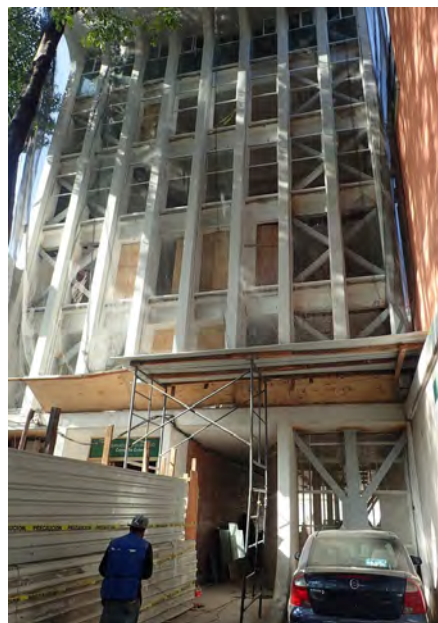
This building, which houses a private medical center, is constructed on a reinforced concrete post and beam frame, with a relatively open ground floor (Figure 7-28). The cross bracing has been applied both outside and inside the building (Figure 2-29), in order to ensure stability at all levels.

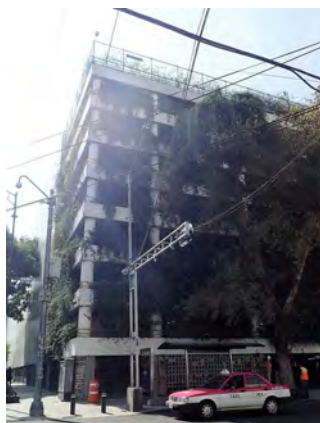
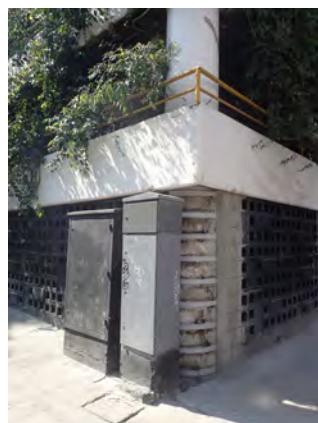
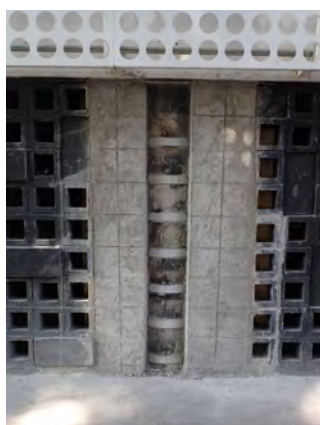
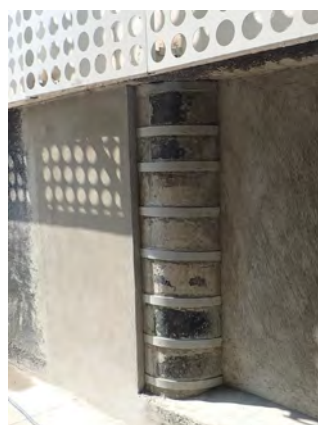
A single example of this type was observed. This technique was implemented to strengthen posts at the ground floor level of an eight story car park (Figure 7-30). Steel strapping was used in order to confine these posts and increase their resistance to compression and shear solicitations. A resin (e.g. epoxy) was injected to fill the cracks present in the posts. Furthermore, the strengthened posts are combined with additional posts (Figure 7-31) and shear panels (Figure 7-33), some of which were already present before the 2017 earthquake (visible on photographs dating from 2008).

It is worth noting that this building does not appear to have incurred any major damage following the September 19th 2017 earthquake (it had not been strengthened at the time), even though its height (8 floors) and design, with its significant surface floor mass, should have rendered it vulnerable.

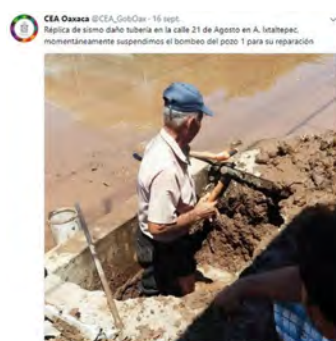
On its website, The Comisión Estatal del Agua of the state of Oaxaca (CEA Oaxaca) featured several repair works carried out in the wake of September 7th earthquake and its aftershocks. This made it possible to monitor the restoration of services in real-time. Judging from online photographs, we can see that repair works were carried out under conditions far from the usual operational practices (non-secured excavations, variable wearing of safety equipment, etc.). The repair team interventions were prompt. The techniques employed (identified on the basis of the photographs) often involved the replacement of a section of metal pipe by a non-metal pipe (it is difficult to determine whether replacements are made of polyethylene, PVC, or composite, etc.). Metal-plastic connectors are also used.

Figure 8.2 – (Pipe repair works in Ixtaltepec (Oaxaca). (Right) Road collapse in Tlahuac (CDMX) due to a damaged water pipe.

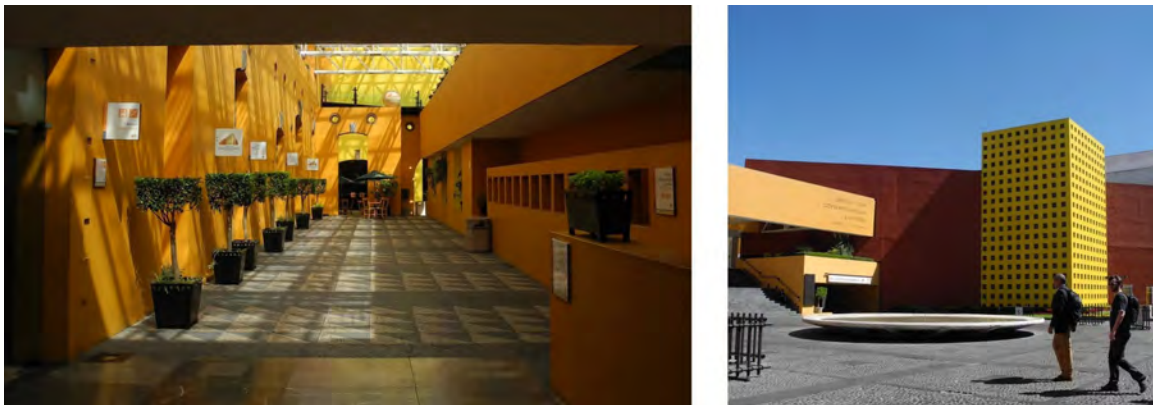
Figure 14.1 – William O. Jenkins Convention Center in Puebla

To this description, we might add that the complex, though composed of very heterogeneous structures, is endowed with remarkable anti-seismic qualities. Not only did the structures behave quite well during the earthquake and did not sustain any damage, but the center itself was fully operational when we visited it, as was the «Centro de Analisis» of the Civil Protection which is based here.

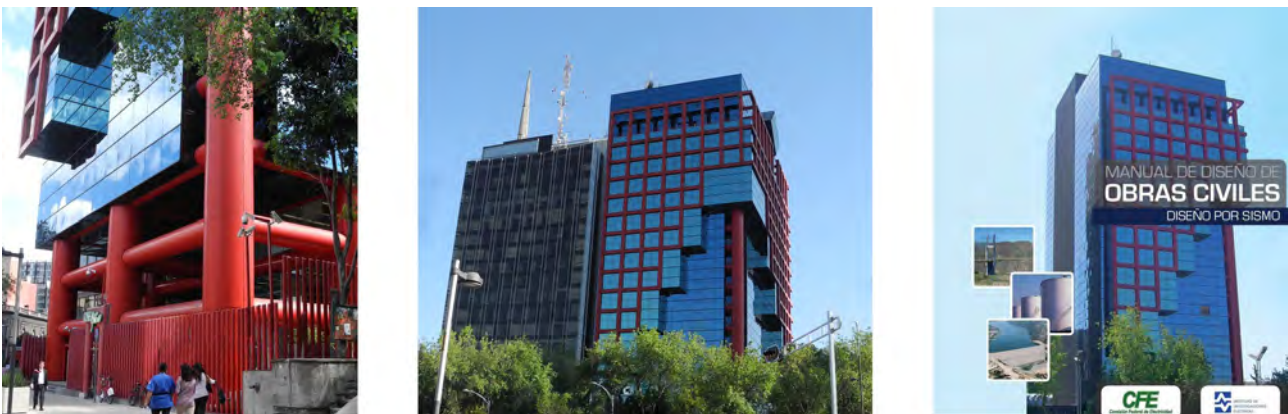
And it is a credit to the authors of this manual that the CFE building, which is neither particularly simple nor regular, but whose red skeleton is a powerful statement, behaved perfectly during the recent earthquake.

Figure 14.3 – The CFE building, la Comisión Federal de Electricidad

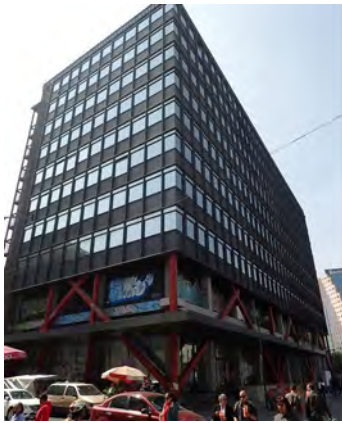
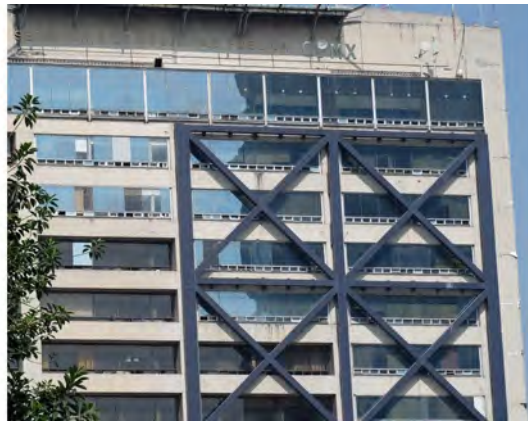
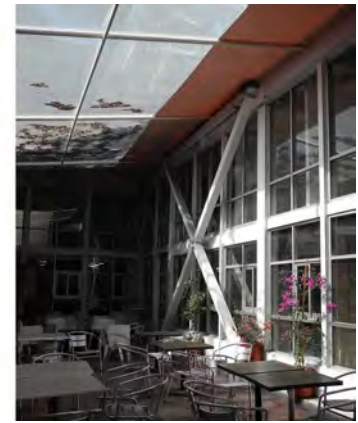
Following the 1985 earthquake, many buildings were retro-fitted with very visible and very expressive steel elements which were added to their façades. Originally probably not designed to last, these emergency reinforcement measures became permanent and eventually endowed the buildings with a strong sense of stability and strength.

This effect can be observed on the IFAL building (French Institute of Latin America) where the exposed cross bracing on all sides creates a rather reassuring feeling.

Figure 14.4 – Seismic retro-fitting of buildings after 1985

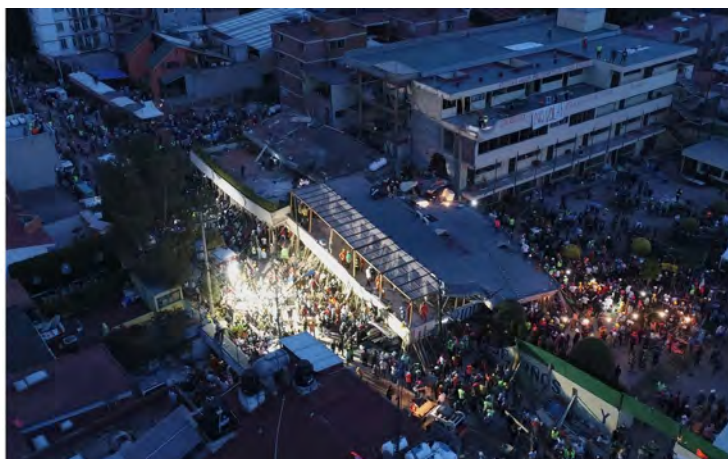
The facts are as follows: At 11:00 on September 19th the “simulacro” (post-seismic drill) took place in the Enrique Rebsamen School, as it had every year on the same date since 1985. The drill proceeded normally, but at 13:34, a real earthquake struck and part of the school building completely collapsed before the eyes of horrified parents. As often nowadays in our hyper-connected societies, people started filming using their smartphones and images rapidly found their way onto the social networks. Many people spontaneously rushed to take part in the rescue operations which would go on for several days under terrible conditions, as attested to by the images. Tragically, this disaster would claim the lives of 19 children and 7 adults.

Figure 14.10 – Rescue operations at the Enrique Rebsamen school (©AFP / Mario Vazquez)

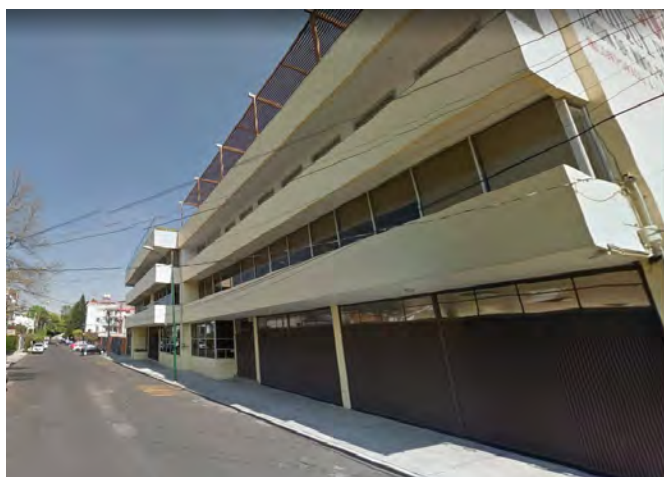
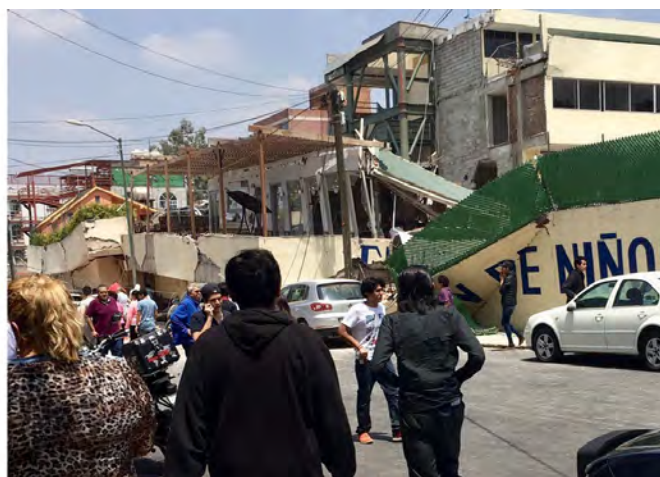
Figure 14.11 – The Enrique Rebsamen school building before and after the event (internet images)

Evidently errors were made, there were short-fallings and omissions on the part of the constructors and, considering the extent of the collapse, the building obviously suffered crucially from a lack of stabilizing elements to combat horizontal stress. Beyond the issue of legal responsibility, there are lessons to be learnt from this tragedy for the benefit of all architects. Etymologically, the architect is the *arkhós-tekton*, the head of the builders. Therefore, ultimate responsibility lies with the architect to design projects that can withstand horizontal stress and to anticipate the provision of the stabilizing elements required to prevent his/her buildings from collapsing like a house of cards.

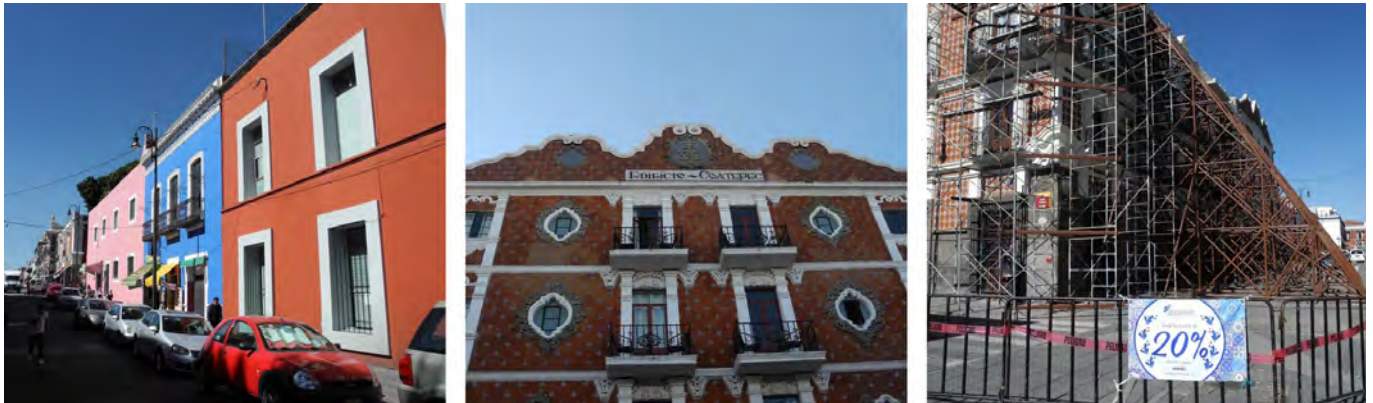
Following this earthquake, major repair and preventive retro-fitting works were initiated and the mission was glad to observe their beneficial impact. During our visit on November 13th 2017, we could see for ourselves that most buildings were intact. Admittedly, some buildings were being supported by struts and reinforcement was visible on church spires, but no building collapses, even partial, had occurred.

Figure 15.3 – Views of Puebla city center

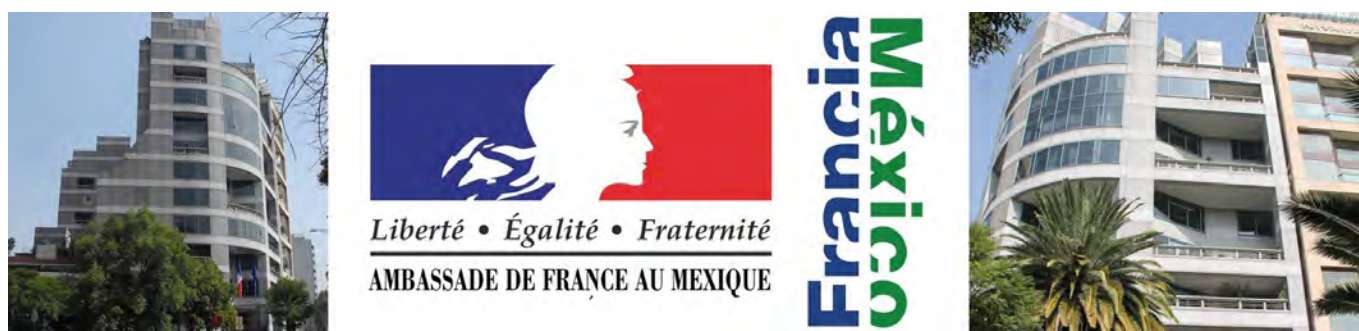
The Embassy and the general consulate are housed in a building constructed between 1992 and 1996 to a design by the French architect Bernard Kohn. It is a rather complex structure with a surface area of 16,850 m<sup>2</sup> and comprising 13 floors including underground car parks with a 110 car capacity. From a structural point of view, the building behaved quite well. The only instances of damage we observed were a cracked partition wall in a meeting room on an upper floor, a few cracks at the junction between the concrete frame and a number of brick infills, and some dislodged cladding elements on the façades. All in all this was quite minor, “normal” damage considering the strength of the earthquake.

Figure 16.1 – The French Embassy in Mexico City

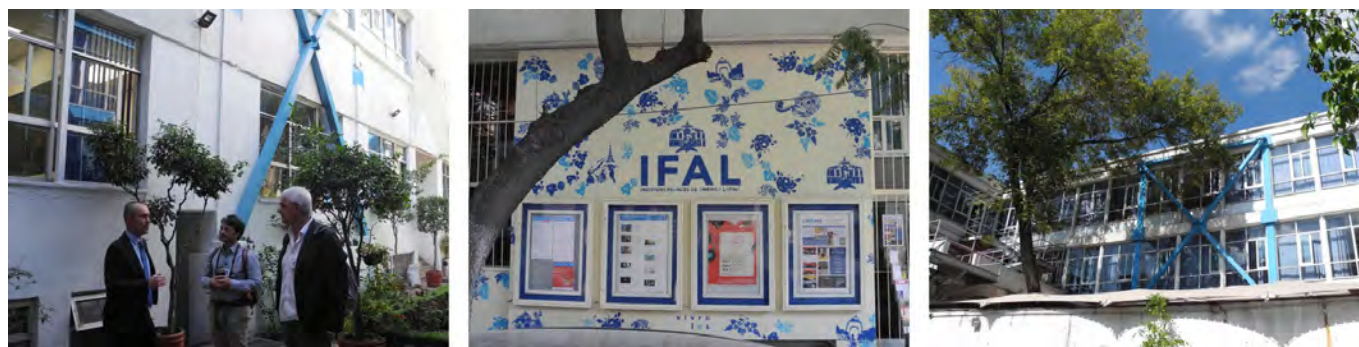
We were able to observe that this rigidification functioned adequately in 2017 as the building displayed only minor cracks, again at the junction between the concrete frame and the brick infill. In this case, the advantage of rigidification is two-fold: on the one hand it strengthens the structure’s stability against horizontal stress (the stability is likely to have been quite weak beforehand. Even though the building survived the 1985 earthquake, it must be regarded as a vulnerable structure), and, on the other hand, it significantly modifies the natural period of the building and, hence, its position on the dimensioning spectrum, with a very favorable impact in terms of stress in this case (of course this depends on the nature of the soil).

Figure 16.2 – The French Institute of Latin America (IFAL) in Mexico City

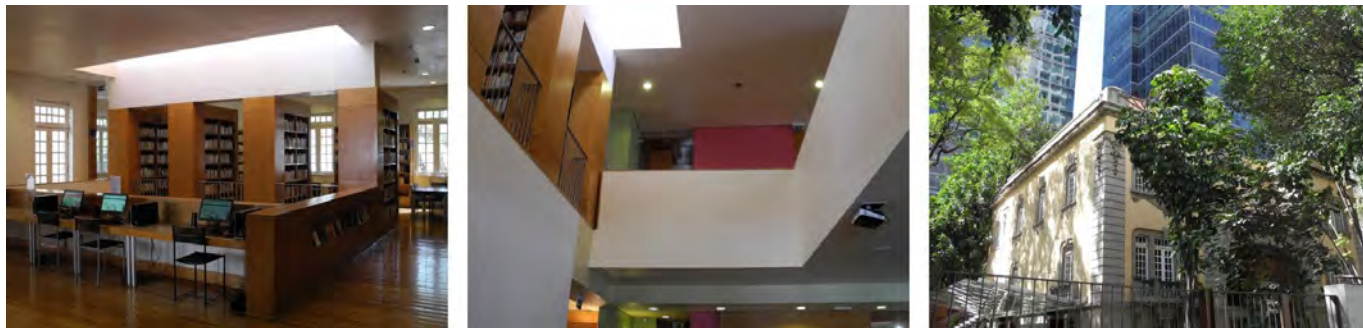
The Casa de Francia is the former French Embassy. It is one of the last 19th century buildings still standing in this sector and is surrounded on all sides by towering high-rises. In 1998, it was transformed into a cultural center by the French architect Bernard Desmoulin. This subtle makeover resulted in a very elegant building which is appreciated as the representation of France in Mexico City. In a 2015 interview, Bernard Desmoulin deplored the fact that “beauty had vanished from the architects’ discourse. It has been banished since the 17th Century, and it already looks like it won’t be back in the 21st”. Obviously this is not the case in Mexico with La Casa de Francia. But this elegance has not been achieved by ignoring the seismic risk. Indeed, the building was in excellent condition when we visited it, apart from minor traces of scraping on a flagstone at the entrance which was the result of a collision between the building and the external stairs.

Figure 16.3 – La Casa de Francia in Mexico City
